ASSESSMENT OF TANNERY BASED SOLID WASTES MANAGEMENT IN ASILI, NAIROBI KENYA

Abstract: Solid wastes generated in Nairobi and its environs are posing a serious environmental challenge to the authorities and public, especially the hazardous and non-biodegradable solid wastes from leather industries. There were environmental concerns and complaints from workers and residents living adjacent to Asili tanneries limited about degradation of natural and inbuilt environment. This pointed to the effect of environmental pollution by the tannery. The broad objective of study was to assess the effectiveness of tannery based solid wastes management, by identifying and analyzing the concentration levels of sodium chlorides, sulphide, chromium ions and total phenols as selected pollutants along the tanning stages, in Nairobi river, borehole water, and soils around the dump site inside the tannery. Experimental (laboratory analysis) design was used. Descriptive statistics was used in analyzing data resulting in means and tables. The means concentration of total Chrome was 2633.38mg/L, Sodium chloride 609.93mg/L, Sulphide 129.77mg/L, total Phenols 10.91mg/L in the soil sampled around the composite

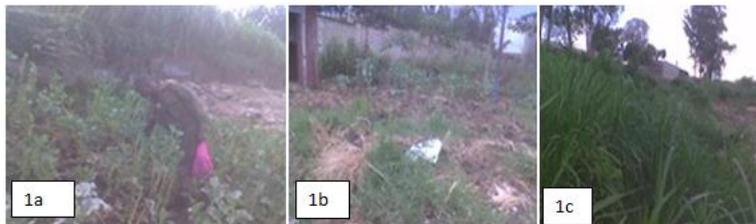
Figure 1. (1a) .A worker picking kales. (1b) and (1c) cassava and Napier grass grown next to the dump site

levels, exposing workers, residents of Njiru and their livestock to high risk of carcinogenic effect either directly or indirectly as seen in plate 1. In Italy and Sweden 20-30% cancer risk were found among tannery workers according to Kolomaznik *et al.*, (2008). Further studies have also shown that even finished leather products—especially those in direct contact with the skin, such as gloves or shoes—contain high levels of a toxic chemical - hexavalent chromium, considered to be a strong allergen that can lead to skin reactions like eczema (Hayes, 1997). Workers in Asili may need regular medical checkups to confirm whether their health is not under threat or compromised by the exposure.

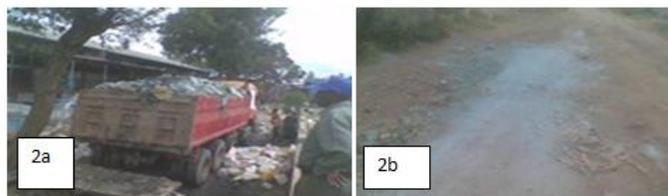
Figure 2. (2a) a vehicle overloaded with wastes. (2b) chrome droppings observed along the road from Aziz tanneries limited

Presence of total chrome in the control soil outside Asili may be suggested to have originated from occasional droppings along the way from open overloaded transporting vehicles as seen in plate 2. Since chrome last longer in the environment it was possible to detect its presence even after a long period as Kolomaznik *et al.*, (2008) states that “Chromium substances persist in the environment beyond 20 years”. Andrew *et*

al., (2010) suggests that contaminated soils from such pollutants need remediation, excavation and removal as cost-effective measures to break the pathway between the contaminant and the local population and then construction of a waste treatment facility and secure landfill to contain them. Failure to put those measures in place is likely to expose the public to the potential entrance of chrome through skin and other
